CHAPTER 3

ENVIRONMENTAL BASELINE STATUS: PHYSICAL ASPECTS

3.2 DIBANG CATCHMENT

Dibang Multipurpose Project is located on river Dibang. The river originates from the snow covered southern flank of the Himalayas / Trans Himalayas

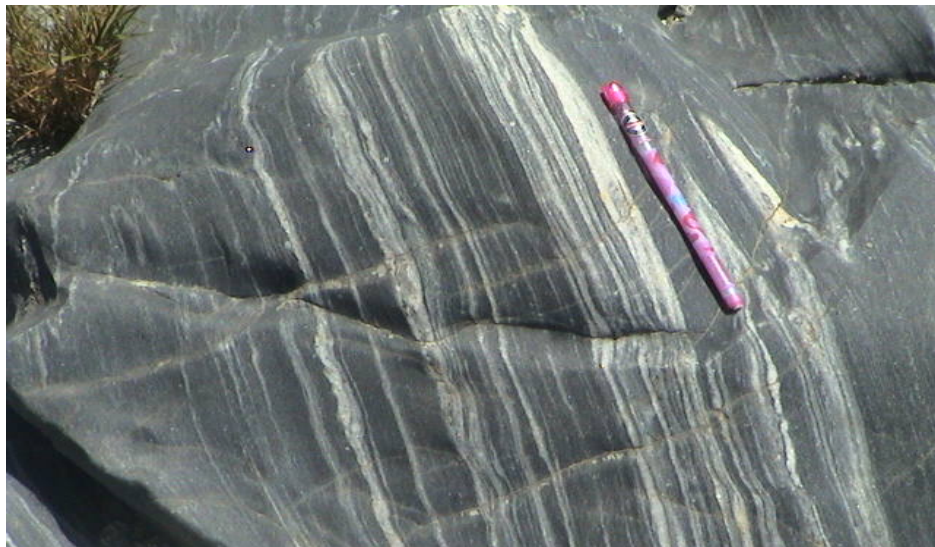
Photo 3.1: Feldspathic biotite gneiss outcrop on the left bank near cane-bridge, downstream of the confluence of Ichi nala with Dibang

schist and graphite schist shows well developed schistosity. At the confluence of the Ahi river with Dibang, the quartz chlorite schist rocks gradually grades into feldspathic gneiss rocks showing steep dips (**Photo 3.1**). At the Ichi nala confluence feldspathic gneiss rock is exposed.

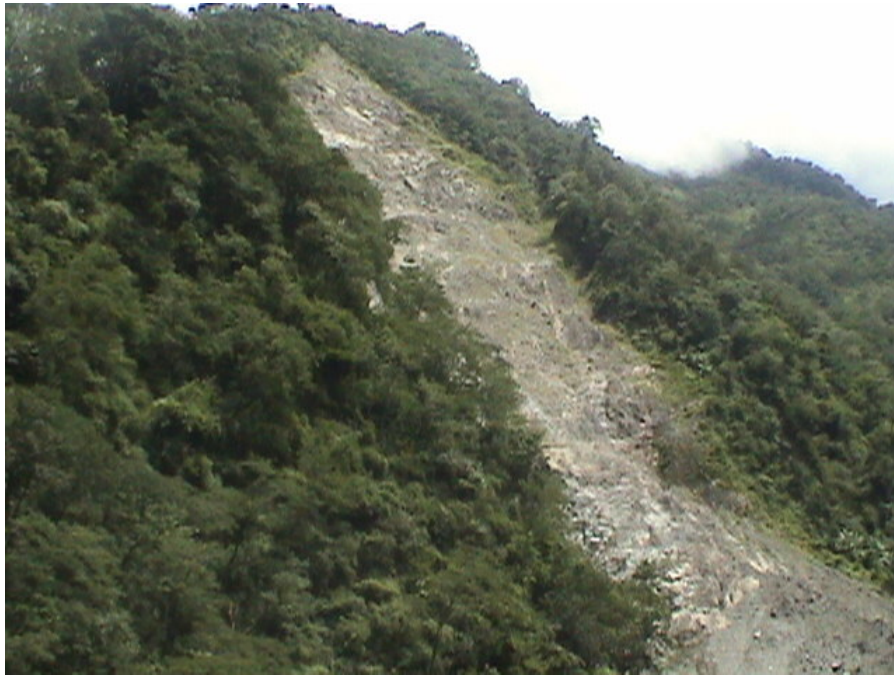
Photo 3.2: Active landslide zone near Airi Pani confluence with Dibang river (about 2 km u/s of Dam axis)

60	L-60	On right bank of Ari Pani (Photograph 3.2).	Planer and wedge failure; Several scarp faces are developed.	Cross joint; Sheared, fractured rock and weathered rock.	No vegetation	Slide in rock	Amphibolite gneiss	No seepage
61	L-61 +	On left bank of Dibang, between Munli-Ashu Pani confluence.	Planer and wedge failure.	Criss cross joint; Joint plane cutting steep hill slopes, weathered rock.	No vegetation	Slide in rock	Feldspathic gneiss	No seepage
62	L-62 +	On left bank of Dibang, u/s of Ashu Pani confluence (d/s of previous slide).	Planer and wedge failure.	Criss cross joint; Joint plane cutting steep hill slopes.	No vegetation	Slide in rock	Amphibolite gneiss	Nala present

As we traverse upstream of the dam area, one major active landslide is present near the confluence of Ari Pani nala with Dibang about 2 km upstream of proposed dam axis (**Photo: 3.2**). This slide has taken place in sheared feldspathic gneiss rock and extends for about 500m above bed level with 150 m width at the base. The slide is active and is formed mainly due to failure along weak shear seams and joint planes which coincides with the steep hill slope. This landslide is indicated as L-60.

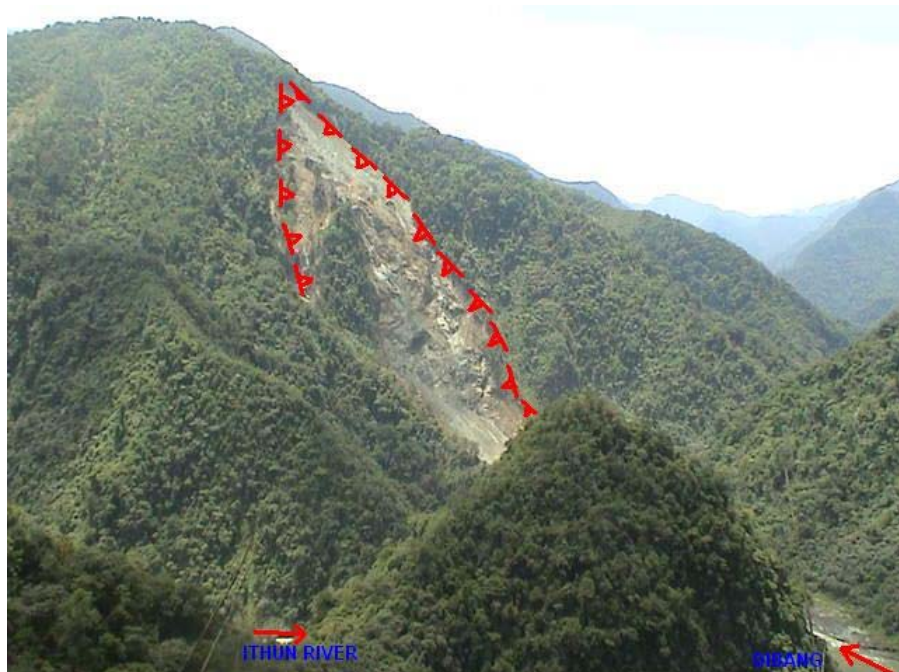
Photo 3.4: Active landslide zone, left bank of Dibang at the confluence of Ithun and Dibang river

39	L-39	On left bank, d/s of Ithun-Dibang confluence. (Photograph 3.4)	Plane failure along steeply dipping joint.	Fractured and closely jointed; Weathered rock zone and schist band; Extensive toe erosion by river Dibang.	No vegetation	Slide in rock	Amphibolite gneiss	Little seepage
40	L-40	On left bank, tributary of Ithun near confluence with Dibang river.	Plane failure.	Criss-cross joints; Weathered rock zone.	No vegetation	Slide in rock	Amphibolite gneiss	Little seepage
41	L-41	On left bank of Ithun, 2.0km u/s of previous slide.	Wedge failure.	Criss cross joints; Joint plane cutting steep hill slope.		Slide in rock	Quartz-chlorite schist	
42	L-42	On left bank of Ithun, 500 m u/s of previous slide.	Plane and wedge failure; Several scarp faces are developed.	Cross joint; Sheared, fractured rock and weathered rock.	Vegetation present	Lower part in rock & upper part in overburden	Feldspathic-amphibolite gneiss

The landslide present at the confluence of Ithun and Dibang river on the left bank is indicated as L-39. This slide is also active in nature (**Photo: 3.4**). It extends up to 500 m elevation from river bed and is about 200 m wide at base. This slide has occurred in amphibolite gneiss/schist which is intruded by several basic dykes. The slide is formed due to planar and wedge failure along the steep hill slopes. High rate of toe erosion by Dibang river is also a major contributory factor. Another major landslide zone indicated as Slide no. L-13 is present about 1.2 km downstream of Enne nala (**Photo: 3.5**). It is formed as a result of planar failure along steeply dipping beds of calcareous quartzite and mica chlorite schist of Hunli formation. High rate of toe erosion and presence of steep valley slope are other contributory factors.

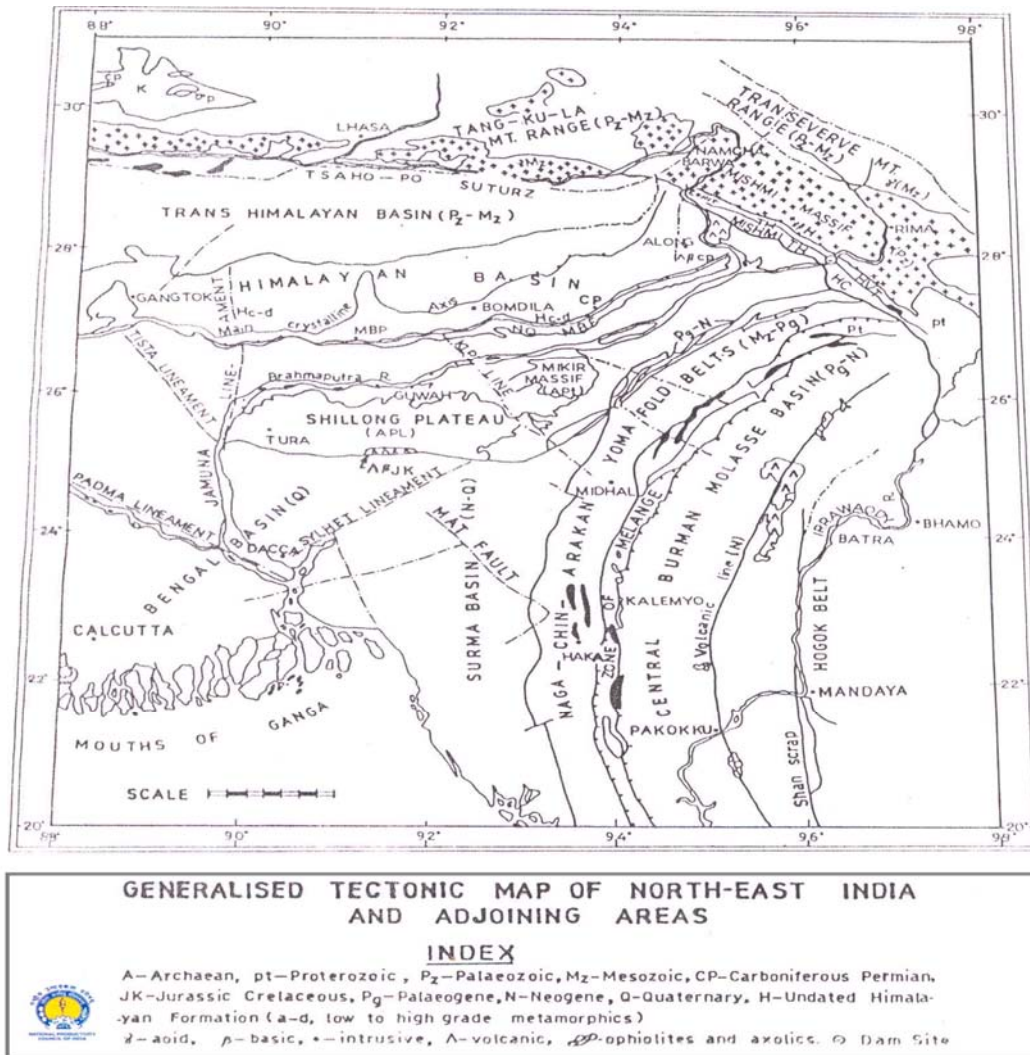
Figure 3.1: Tectonic Map of North East

In the figure 3.1 generalized Tectonic map of North East India is shown. The East West structural trend of the Himalaya has- taken a sharp bend towards North East - North in the Siang Valley, Arunachal Pradesh. The available geological information do not indicate physical continuity of the Himalayan rock units across the Siang fracture (Nandy, 1980) into the Mishimi block, rather the north east trending elements of Arunachal Himalaya with its thrust sheets abut against the north-west trending structural grain of the Mishimi block. The MGT and the MBT are the two major crustal discontinuity extending west to east through out Himalaya, but these do not represent single dislocation plane. The MBT is well exposed all along the southern margin of Arunachal Himalaya upto Siang river, while MCT is yet doubtful about its extension. Thrusting along the MBT is a late event involving the youngest Siwalik rocks of Pliocene to Pleistocene age. Besides these longitudinal thrusts / faults, many oblique to transverse faults lineaments cut across the Himalaya, some of which are regionally extensive and traverse from fore deep to ITZ through Himalaya. Few of these caused noticeable off sets on MBT & MCT in the Siang fracture zone.

The Seismotectonic Map of the area around the project site is shown in figure 3.1. The proposed project lies in the junction of Himalayan tectonic and Mishimi tectonic domain, more specifically the project site lies between active Mishimi thrust and Lohit thrust trending & paralleling in NW-SE direction with North Easterly dipping. 24 number of earthquake epicentres lie on the east of the thrust, 16 between the two thrust and 10 to 15 in the south of the Mishimi thrust.

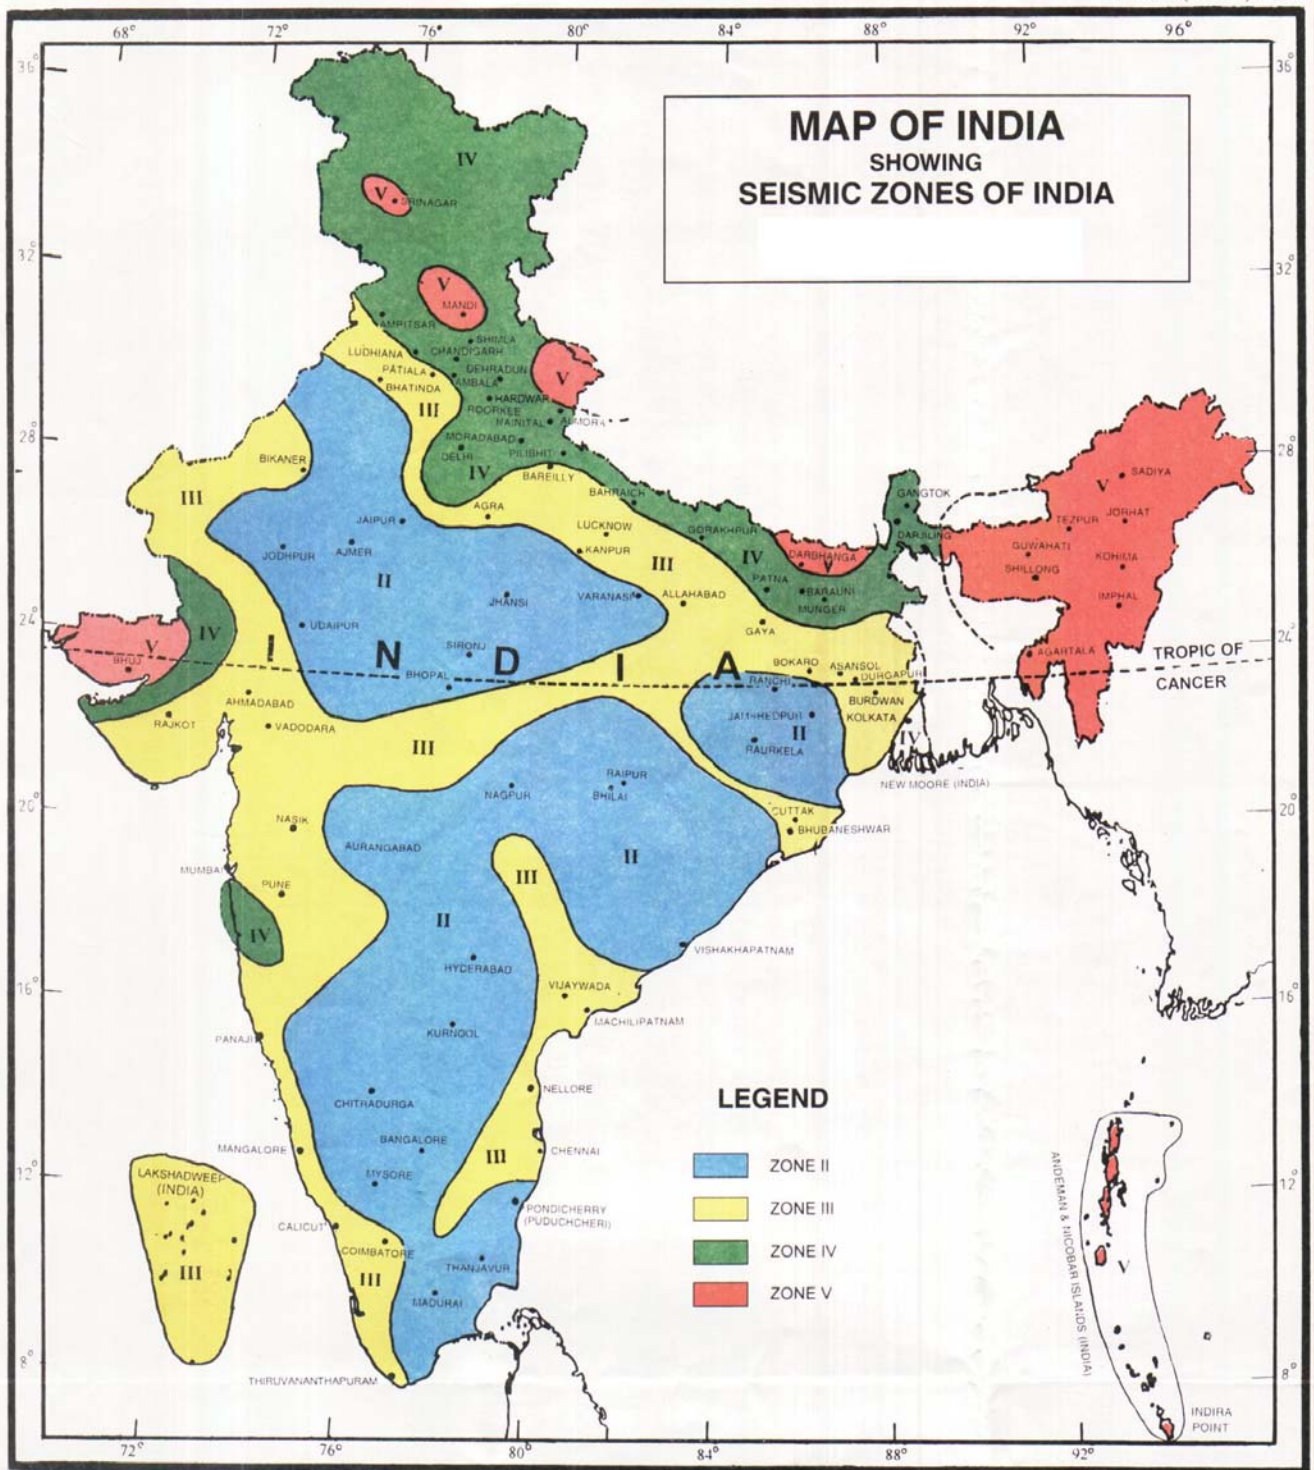
Map 3.8: Seismo-tectonic Map of India

Besides, a number of events of $5.0 < M < 6.0$ occurred around the proposed project site. The area has experienced highest intensity being of the order of IX to X during 1950 Great Assam Earthquake. Due to this earthquake, Dibang river, along with other tributaries were blocked by landslides. During the Assam Earthquake of 1897, this area experienced intensity of the order VIII on mm scale. Further, as per Earthquake Zoning map of India this area falls within Zone V (Map 3.8).

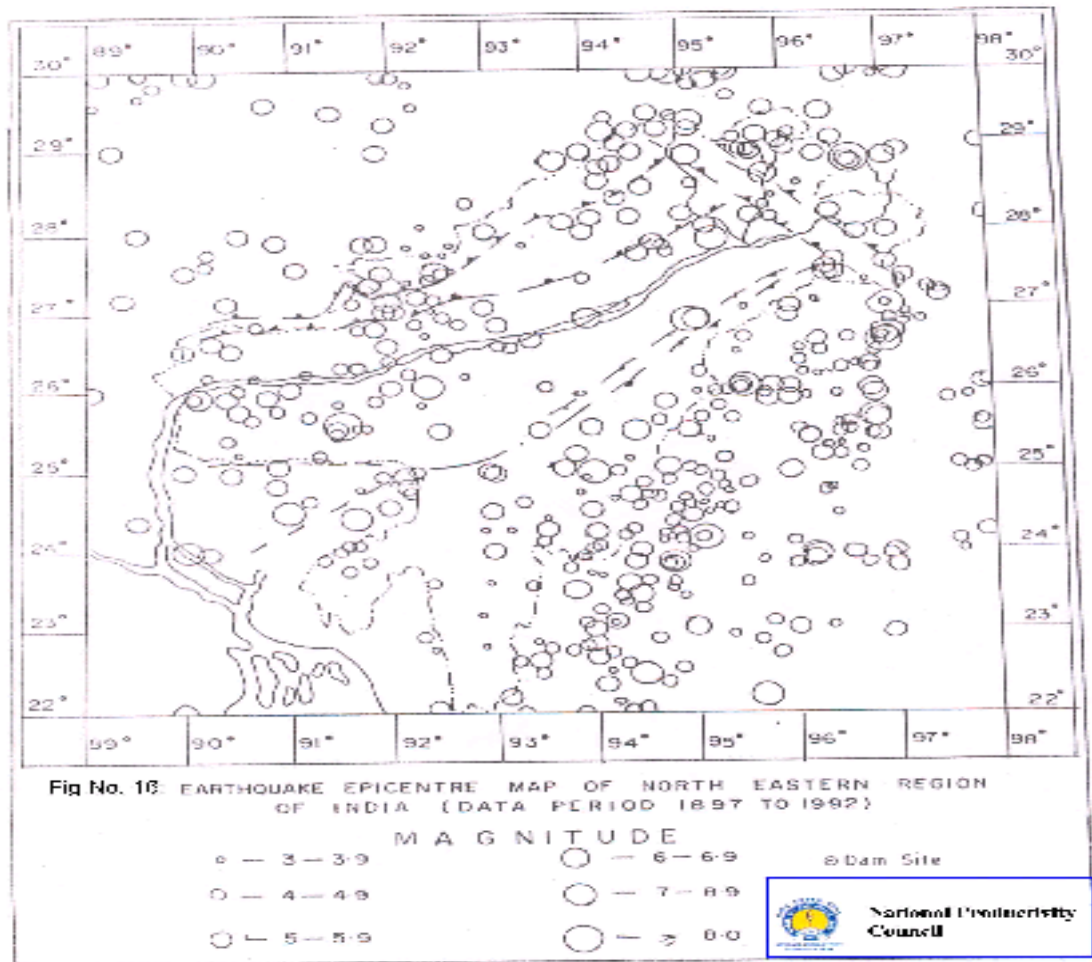
Figure 3.2: Earthquake epicentre

The earthquake epicentre map of NEI (figure 3.3) reveals that the area around the project site is a potential source of seismic event. The Great Assam Earthquake of 1950 ($M > 8.5$) has occurred within 50 km radius, while number of major earthquakes $7.0 < M < 8.0$ have occurred within 100 km radius of the project site.
